PIPELINE OBSERVATION SYSTEM MANAGEMENT
Project Information

Project: CITY OF MOUNTAIN VIEW

Upstream MH: F5-52

Downstream MH: F5-34

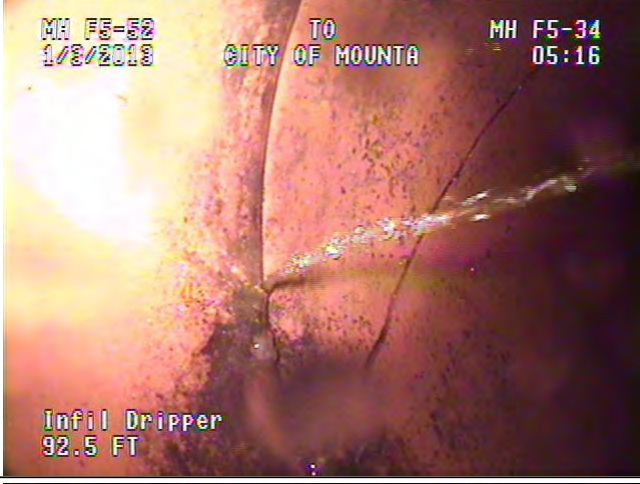
<p>MH F5-52 TO MH F5-34 1/3/2013 CITY OF MOUNTAIN VIEW 05:13</p> <p>Start Inspection 0.0 FT</p>
92.5	Infil Dripper Position: 12 Severity: None Maint Weight: 3	03:25

<p>MH F5-52 TO MH F5-34 1/3/2013 CITY OF MOUNTAIN VIEW 05:16</p> <p>Infil Dripper 92.5 FT</p>
96.6	Infil Runner Position: 9 Severity: None Maint Weight: 4	03:47

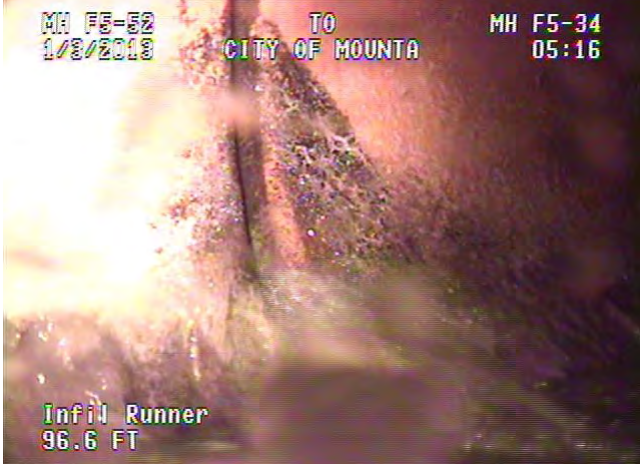
<p>MH F5-52 TO MH F5-34 1/3/2013 CITY OF MOUNTAIN VIEW 05:16</p> <p>Infil Runner 96.6 FT</p>

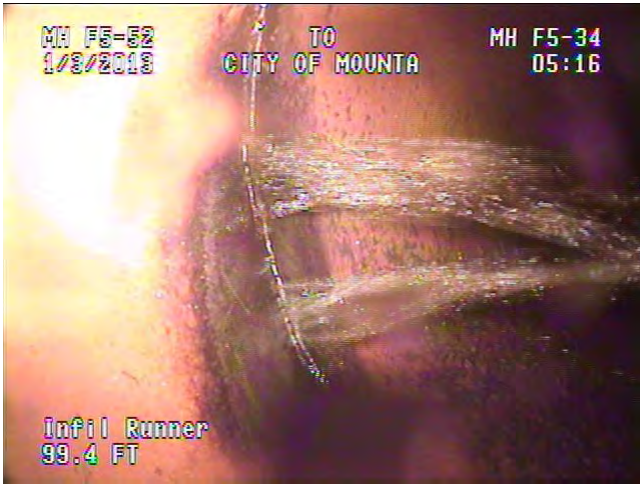
Distance	Fault Observation	Time	Picture
99.4	Infil Runner Position: 11 Severity: None Maint Weight: 4	04:05

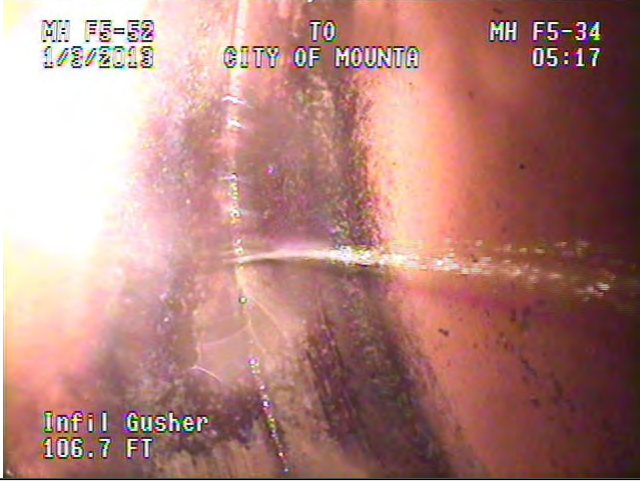
106.7	Infil Gusher Position: 10 Severity: None Maint Weight: 5	04:32

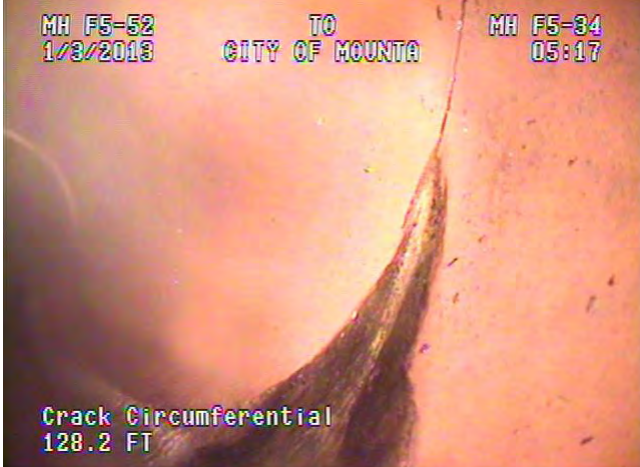
128.2	Crack Circumferential Position: 11 To 4 Severity: None Struct Weight: 1	05:14
